EVALUATION OF BLUE SILK/G.P.I. MARK 4A - PART II

PERFORMANCE OVER VARIOUS TERRAINS AND UNDER
SIMULATED OPERATIONAL CONDITIONS

Report No. AARE/Tech/122/Nav. Part II

AEROPLANE AND ARMAMENT EXPERIMENTAL ESTABLISHMENT
BOSCOMBE DOWN.

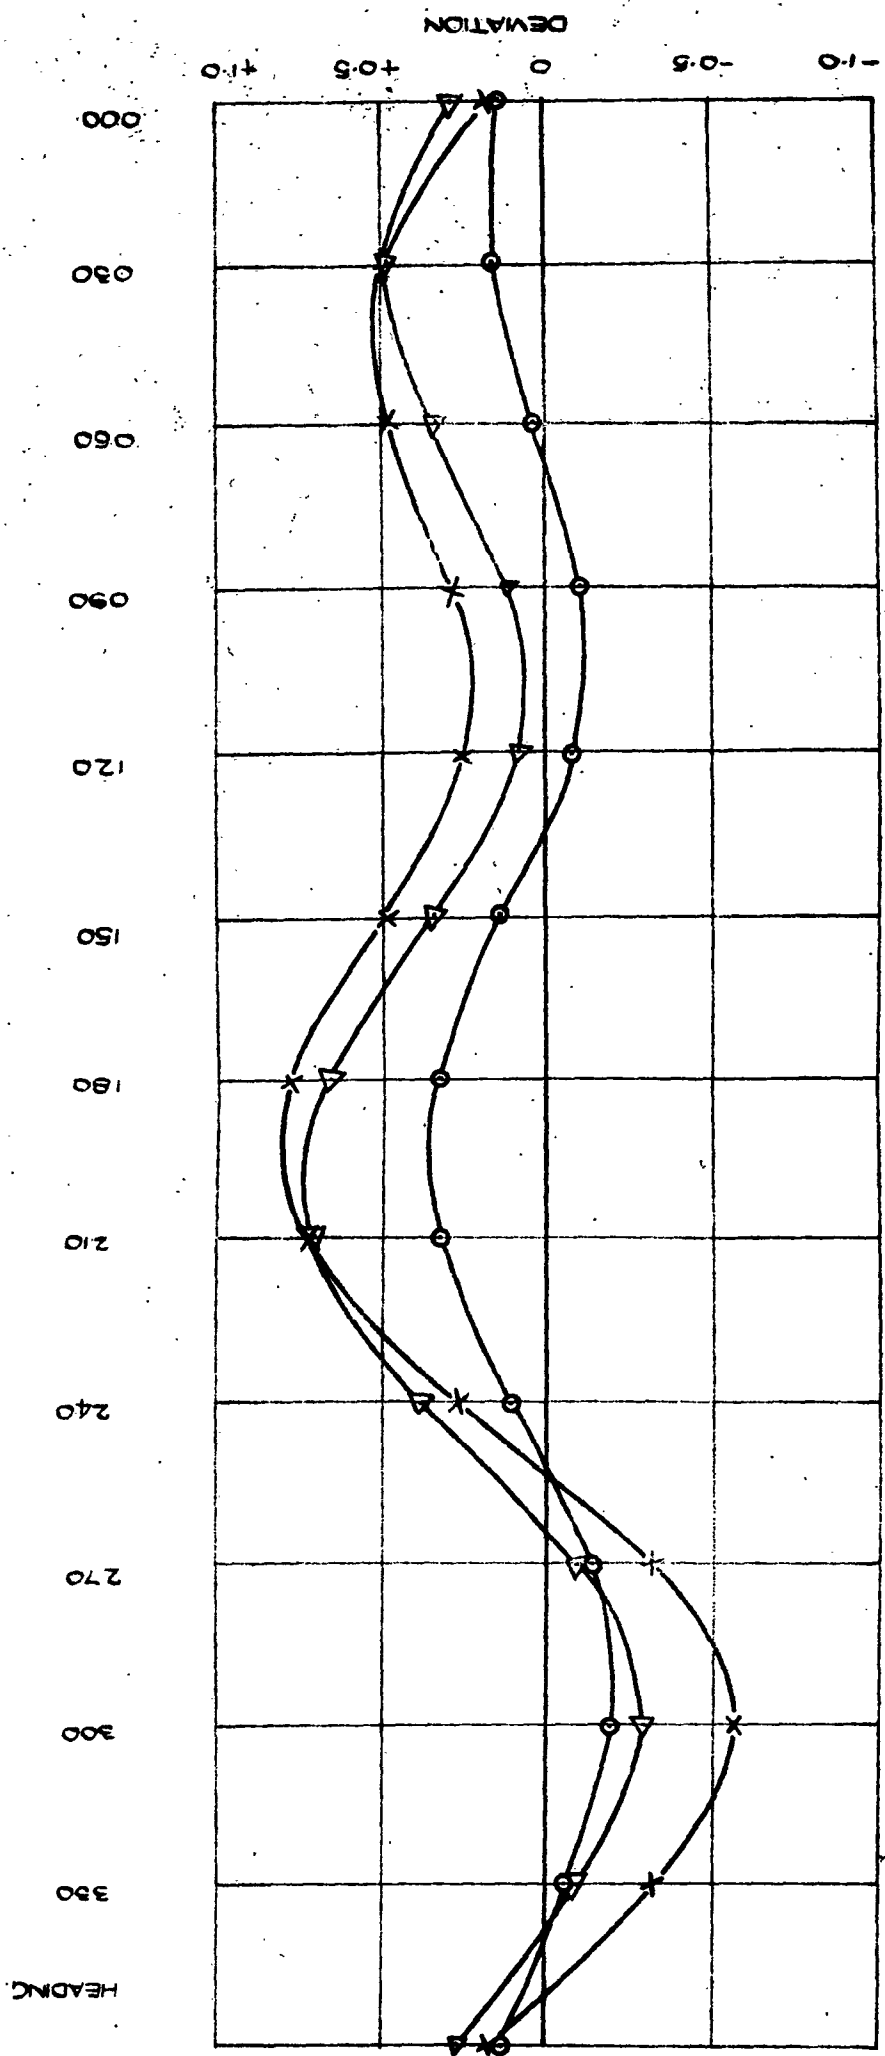
FIG. 3

3.2.2 All ground compass calibrations were carried out using the Watts Datum Compass. The maximum 50% error of determination of deviation on any single heading was $\pm 0.10^\circ$. The graphed deviations for the calibrations listed in sub-Paras 3.2 (a), (b) and (c) are given in Fig. 3 and those for sub-Paras 3.2 (d), (e) & (f) are given in Fig. 4. The results of the calibrations are very consistent, and the reduction in the residual deviations found at El Adem can be attributed to the lower magnetic latitude.

GROUND CALIBRATIONS-GIVE COMPASS.

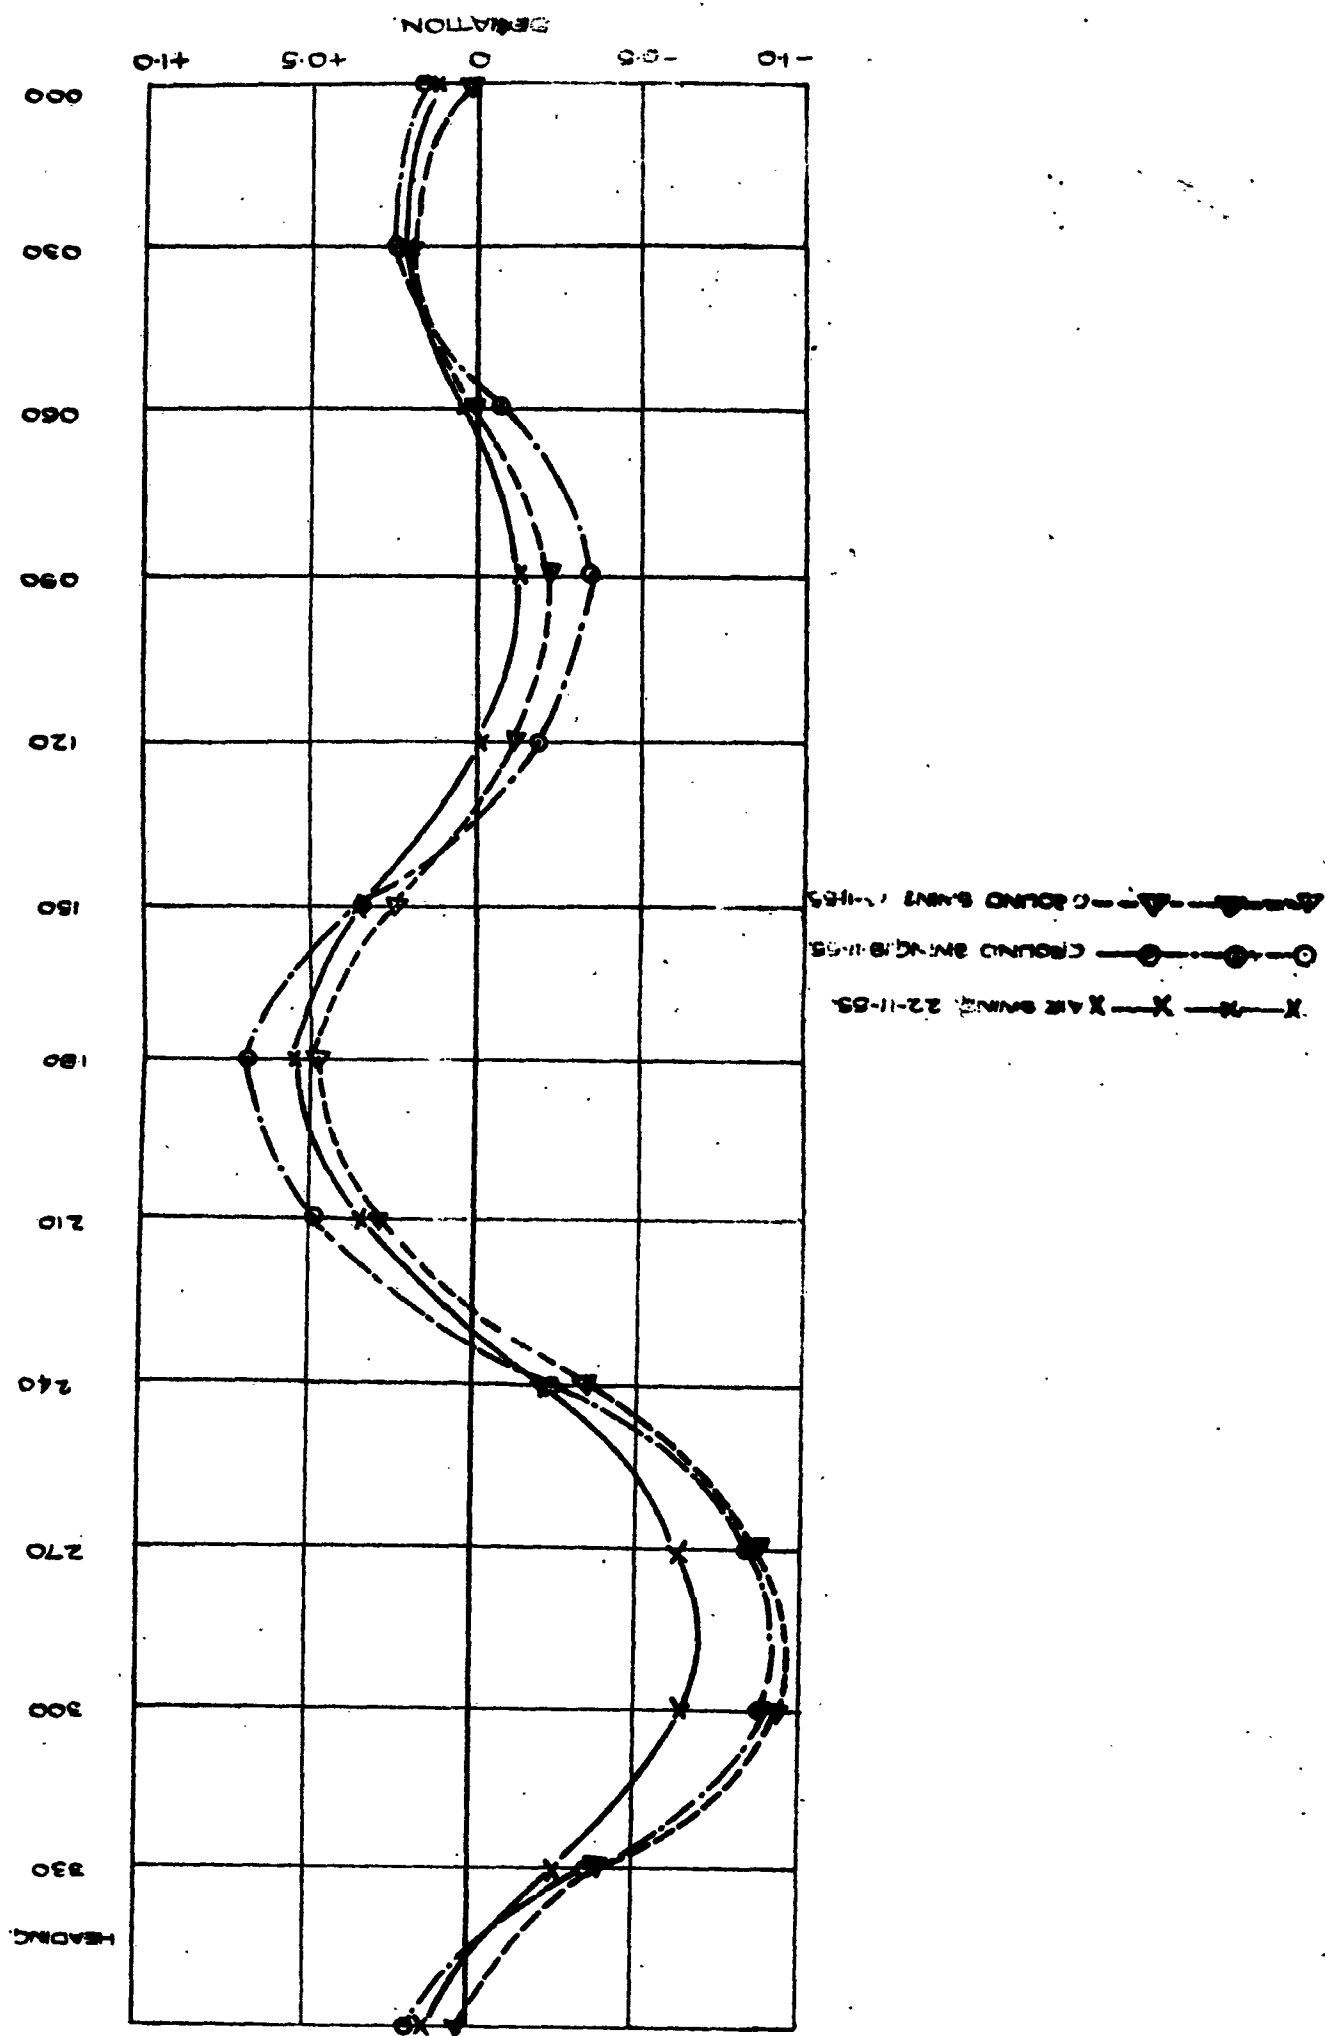
FIG.4

3.2.3 Results obtained in Phase I of the trial tended to indicate that there might be considerable changes in the value of deviation between the ground and air conditions. It was therefore decided to carry out an air calibration using the Azimuth Datum Instrument Mk. 2. This was done on 22nd November, 1955, and ground calibrations were done on 18th and 23rd November for comparison. The graphed deviations for these three calibrations are shown superimposed in Fig. 4. It will be seen that the three curves are similar in shape, but that the maximum value of deviation in the air is less than that found on the ground. The 50% error of a single observation of deviation for the air calibration was $\pm 0.16^\circ$.

COMPARISON OF GROUND & AIR CALIBRATIONS GIVE COMPASS.
